MANAGING POWER

LESSONS LEARNED FROM NATIONAL POWER BLACKOUTS

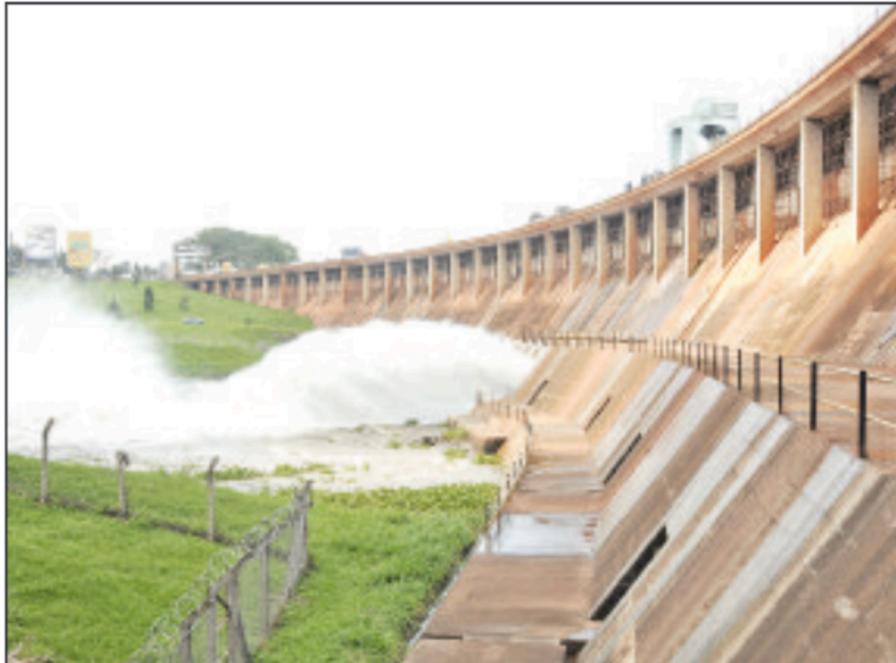
The incident caused electricity generation disruption as the water intake screens were clogged with debris from the floating island, cutting off flow to the turbines and the cooling water system of the power plant. By half-past midday, the situation had deteriorated and the generation units at Nalubaale-Kiira hydropower plant complex tripped, triggering a national blackout.

Nalubaale dam has been affected by floating island and rise in water levels

- Power system stability associated with frequency and voltage fluctuations is of great concern. In order to ensure energy security and reliability of supply, there is need for an independent panel of experts to evaluate and assess the capability of the power transmission system to withstand system fluctuations and recommend improvement measures to the Government.
- The hydraulic structures of hydropower plants are exposed to serious dam safety and revenue generation loss without a robust log boom in place to contain not only floating debris, but the emerging threat of floating islands. The need to redesign and install log booms and/or waterway barriers at Jinja dam cannot be overemphasised.
